### GEOTECHNICAL INVESTIGATION REPORT

> COMMERCIAL BUILDING 37 SOUTH WATER STREET HENDERSON, NEVADA

> > DEI No.: 18-0379

SEPTEMBER 4, 2018

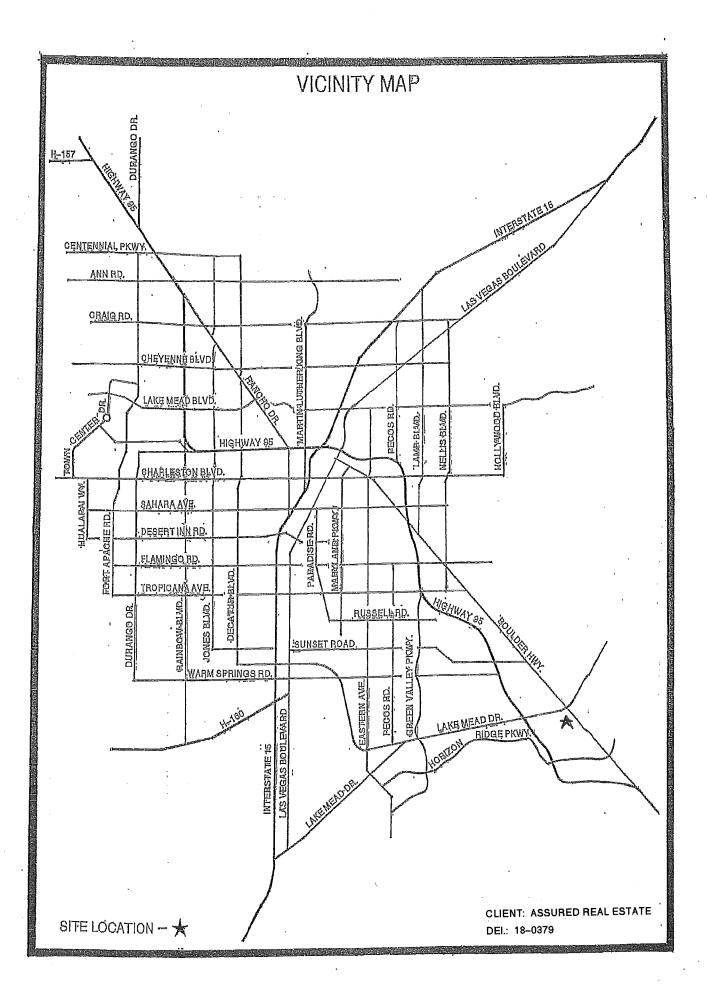
### SITE PLAN ASSURED REAL ESTATE 37 SOUTH WATER STREET HENDERSON, NEVADA

A subsurface exploration of the site was conducted by drilling two 15-foot deep borings at the approximate locations shown on the Site Plan. The borings were made using a truck-mounted drill

The proposed development consists of a commercial building to be located on an approximate 0.44 acre lot at 37 South Water Street in Henderson, Nevada. The APN for the site is 179-18-611-056. The structure will be one-story in height of wood-frame construction and have a slab-on-grade concrete floor. Design loads have not been provided to us; therefore, we have assumed loads typical for this type of construction. The site location is shown on the Vicinity Map and a Site Plan has been provided which illustrates the lot layout.

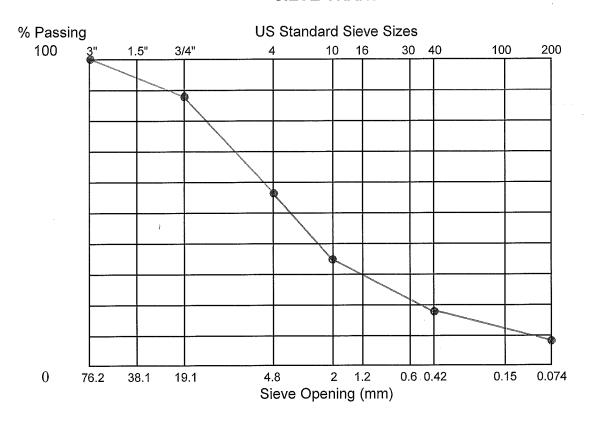
### SIEVE CHART

Sieve Size	% Passing	$D_{60} = NA$
3-inch	100	$D_{30} = NA$
3/4-inch	88	$D_{10} = NA$
No. 4	57	
No. 10	35	$C_u = NA$
No. 40	18	$C_c = NA$
No. 200	7.8

Atterberg Limits	Soil Classification by USCS
LL = NA	Silty Sand (SM) with gravel
PL = NA	
PI = NP	Boring B-1 @ 5 feet

Laboratory testing on selected samples included, Atterberg Limits (ASTM D4318) and gradation (ASTM D1140). The results of these tests are included on the boring logs and in the Appendix.

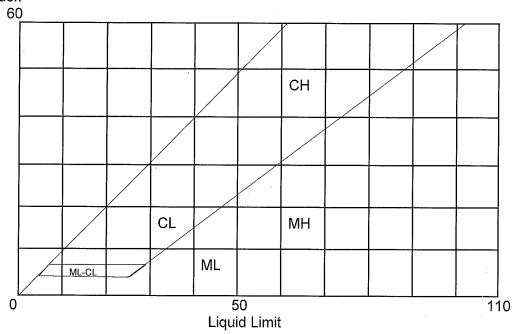
### ATTERBERG LIMITS CHART

Boring No.	Depth	Symbol	Liquid Limit	Plastic Limit	Plasticity Index	Classification
1	5		_	-	NP	Silt

Note: The Atterberg Limits test is performed on soils passing the #40 sieve screen. Therefore, the classification indicated in the table above represents the behavior of the soils passing the #40 screen only.

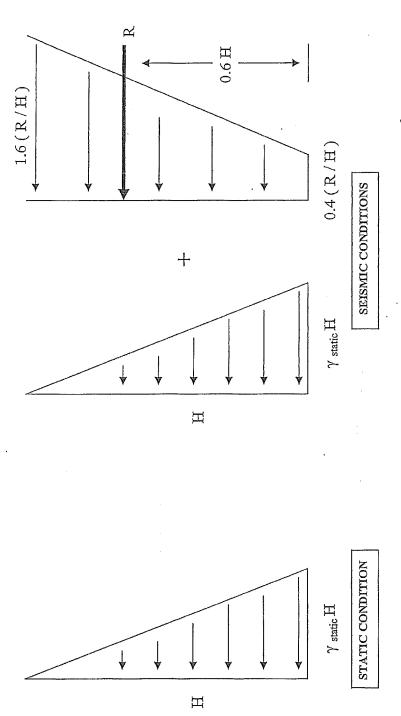
# Earth Pressure Distribution

$R = Resultant \ of \ seismic \ component \ of \ earth \ pressure \ per \ unit \ length \ of the \ wall = \% \ (\gamma \ _{seismic} - \gamma \ _{static}) \ H^2.$

$H=Height\ of\ the\ wall$   $\gamma=Height\ of\ the\ value for\ active\ or\ at\ rest\ conditions,\ as\ applicable.$  Note: Surcharge pressure is not included here and should be added, if applicable.

Under seismic conditions, the active and at-rest equivalent fluid unit weight should be increased to 54 and 120 pcf, respectively. The resultant of the seismic component of earth pressure (i.e., the difference between seismic and static conditions) should be applied at 0.6 of the height where lateral soil pressure is acting. If seismic lateral pressure distribution is needed, it may be taken as an inverted trapezoid (see attached Earth Pressure Distribution Figure).
